# Manhole Inspection Summary

## Manhole # S21WW1125MH

Record Plat: **21WW1** Node: **125** Status: **New Manhole (Not in GIS)** Insp Date: **1/2/07 12:00 AM**

**Location** Address: **2 ROLAND GREEN**

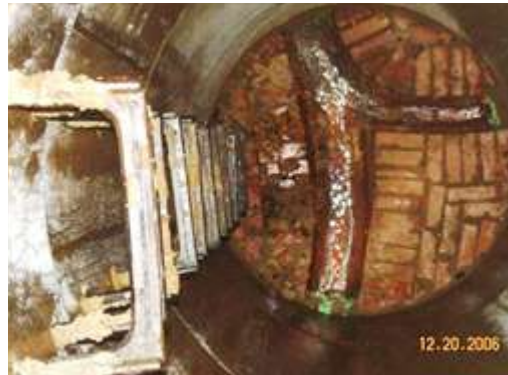
Top View

Evidence of surcharge - Bench debris.  
Channel debris.

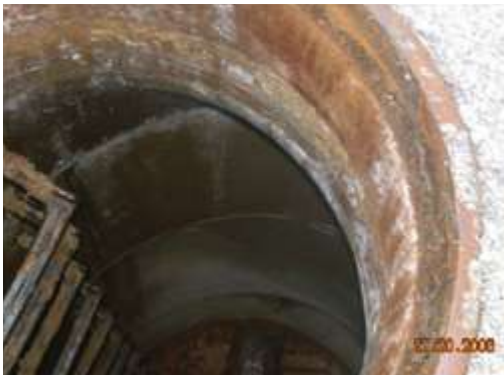
Defect

**Frame** Offset: **0** (in.) Condition: ☐ Sound ☐ Cracked ☒ **Leaks**

Infiltration: ☐ None ☒ **Joint** ☐ Cracks ☐ Mortar ☐ Roots ☒ **Wall**

Frame leaks. Adjustment, Corbel and  
Barrel infiltration.

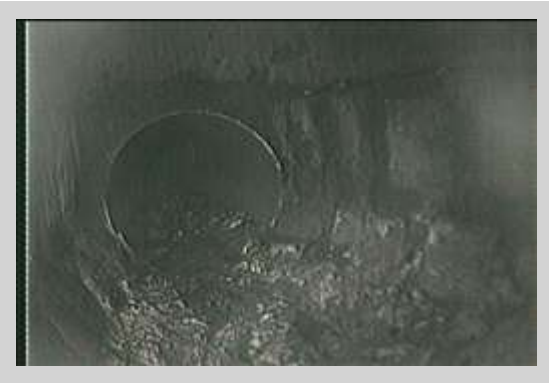
### 8 in. Circular Gravity Sewer Pipe Out @ 12 O'Clock

Invert Depth: **13.55** (ft.) Flow Characteristics: **Slow**

Deposits: ☐ None ☒ **Mud** ☐ Sludge ☒ **Debris** ☒ **Grease**

Silt Depth: **1** (in.) Deposits Extent: **Light**

Infiltration: **Evidence** Pipe Seal Cond: **Unknown**

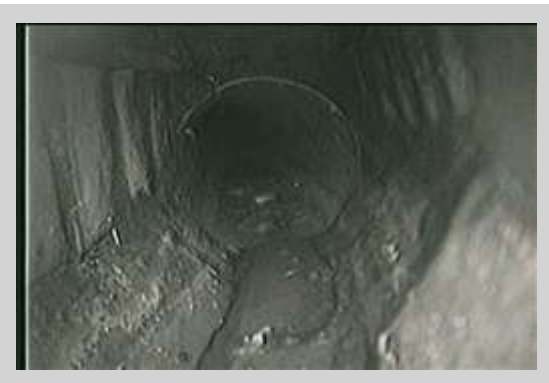
### 6 in. Circular Gravity Sewer Pipe In @ 3 O'Clock

Invert Depth: **13.54** (ft.) Flow Characteristics: **None**

Deposits: ☐ None ☒ **Mud** ☐ Sludge ☒ **Debris** ☒ **Grease**

Silt Depth: **0.5** (in.) Deposits Extent: **Light**

Infiltration: **Evidence** Pipe Seal Cond: **Cracked**

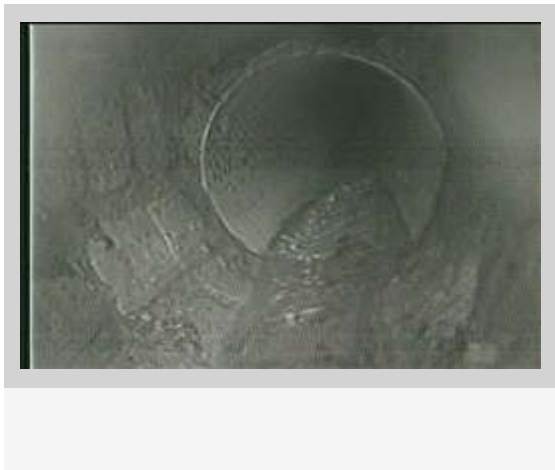
8 in. Circular Gravity Sewer  
Pipe In @ 7 O'Clock

Invert Depth: **13.37** (ft.) Flow Characteristics: **Slow**

Deposits: ☐ None ☒ **Mud** ☐ Sludge ☒ **Debris** ☐ Grease

Infiltration: **Evidence** Pipe Seal Cond: **Cracked**
